KEY MAP Sediment Probing Interpretation Bound Brook OU4 RI/FS

Bound Brook OU4 RI/FS

Cornell-Dubilier Electronics
Superfund Site
South Plainfield, New Jersey

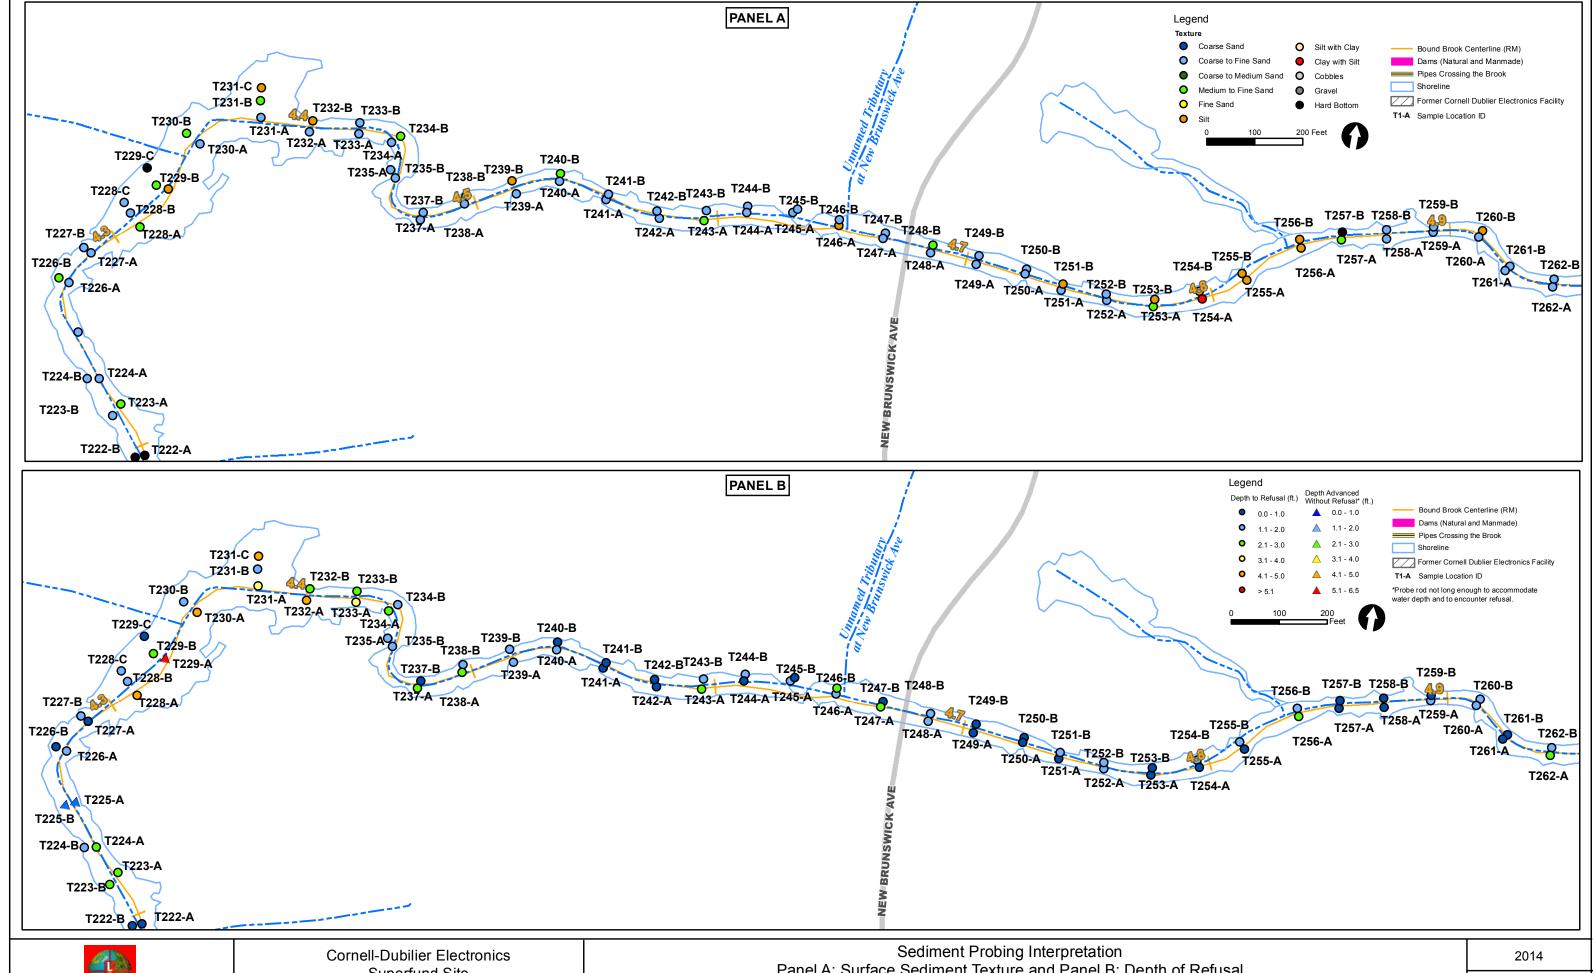
Figure 3-2 Sheet 8 of 11

Panel A: Surface Sediment Texture and Panel B: Depth of Refusal Bound Brook OU4 RI/FS

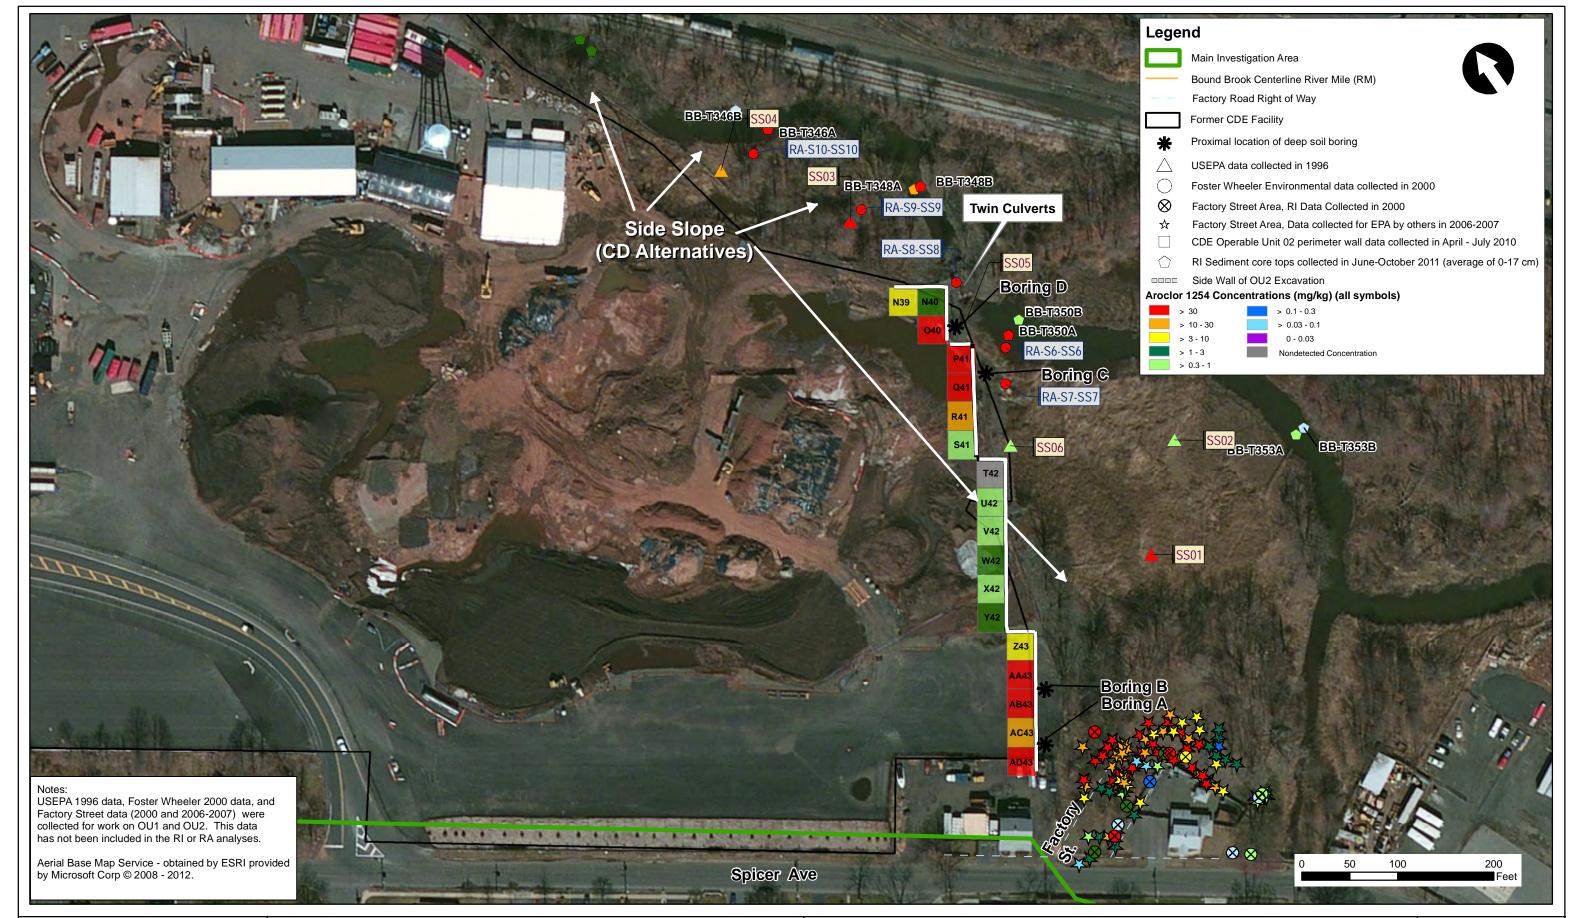
Figure 3-6

CD RAA Sampling Results
Bound Brook OU4 RI/FS

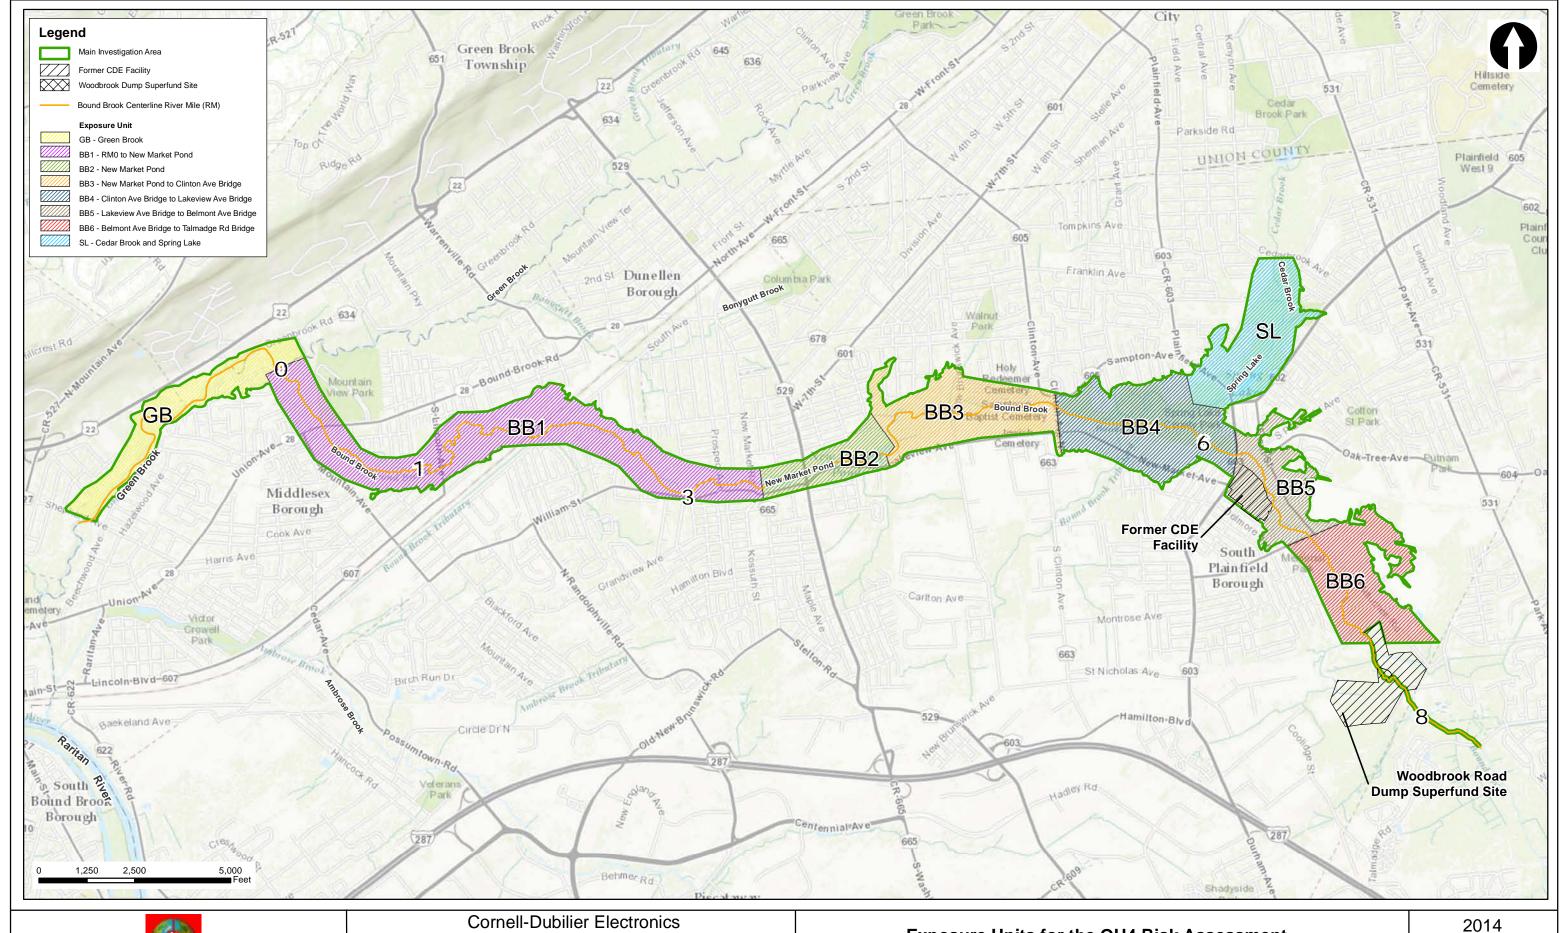
Figure 3-11

Exposure Units for the OU4 Risk Assessment Bound Brook OU4 RI/FS
